HARRY S TRUMAN NATIONAL HISTORIC SITE

INDEPENDENCE, MISSOURI

Historic Structures Report

Restoration Associates  
a division of  
Solomon Claybaugh Young Architects Inc.  
20 West 9th Street Kansas City, Missouri 64105

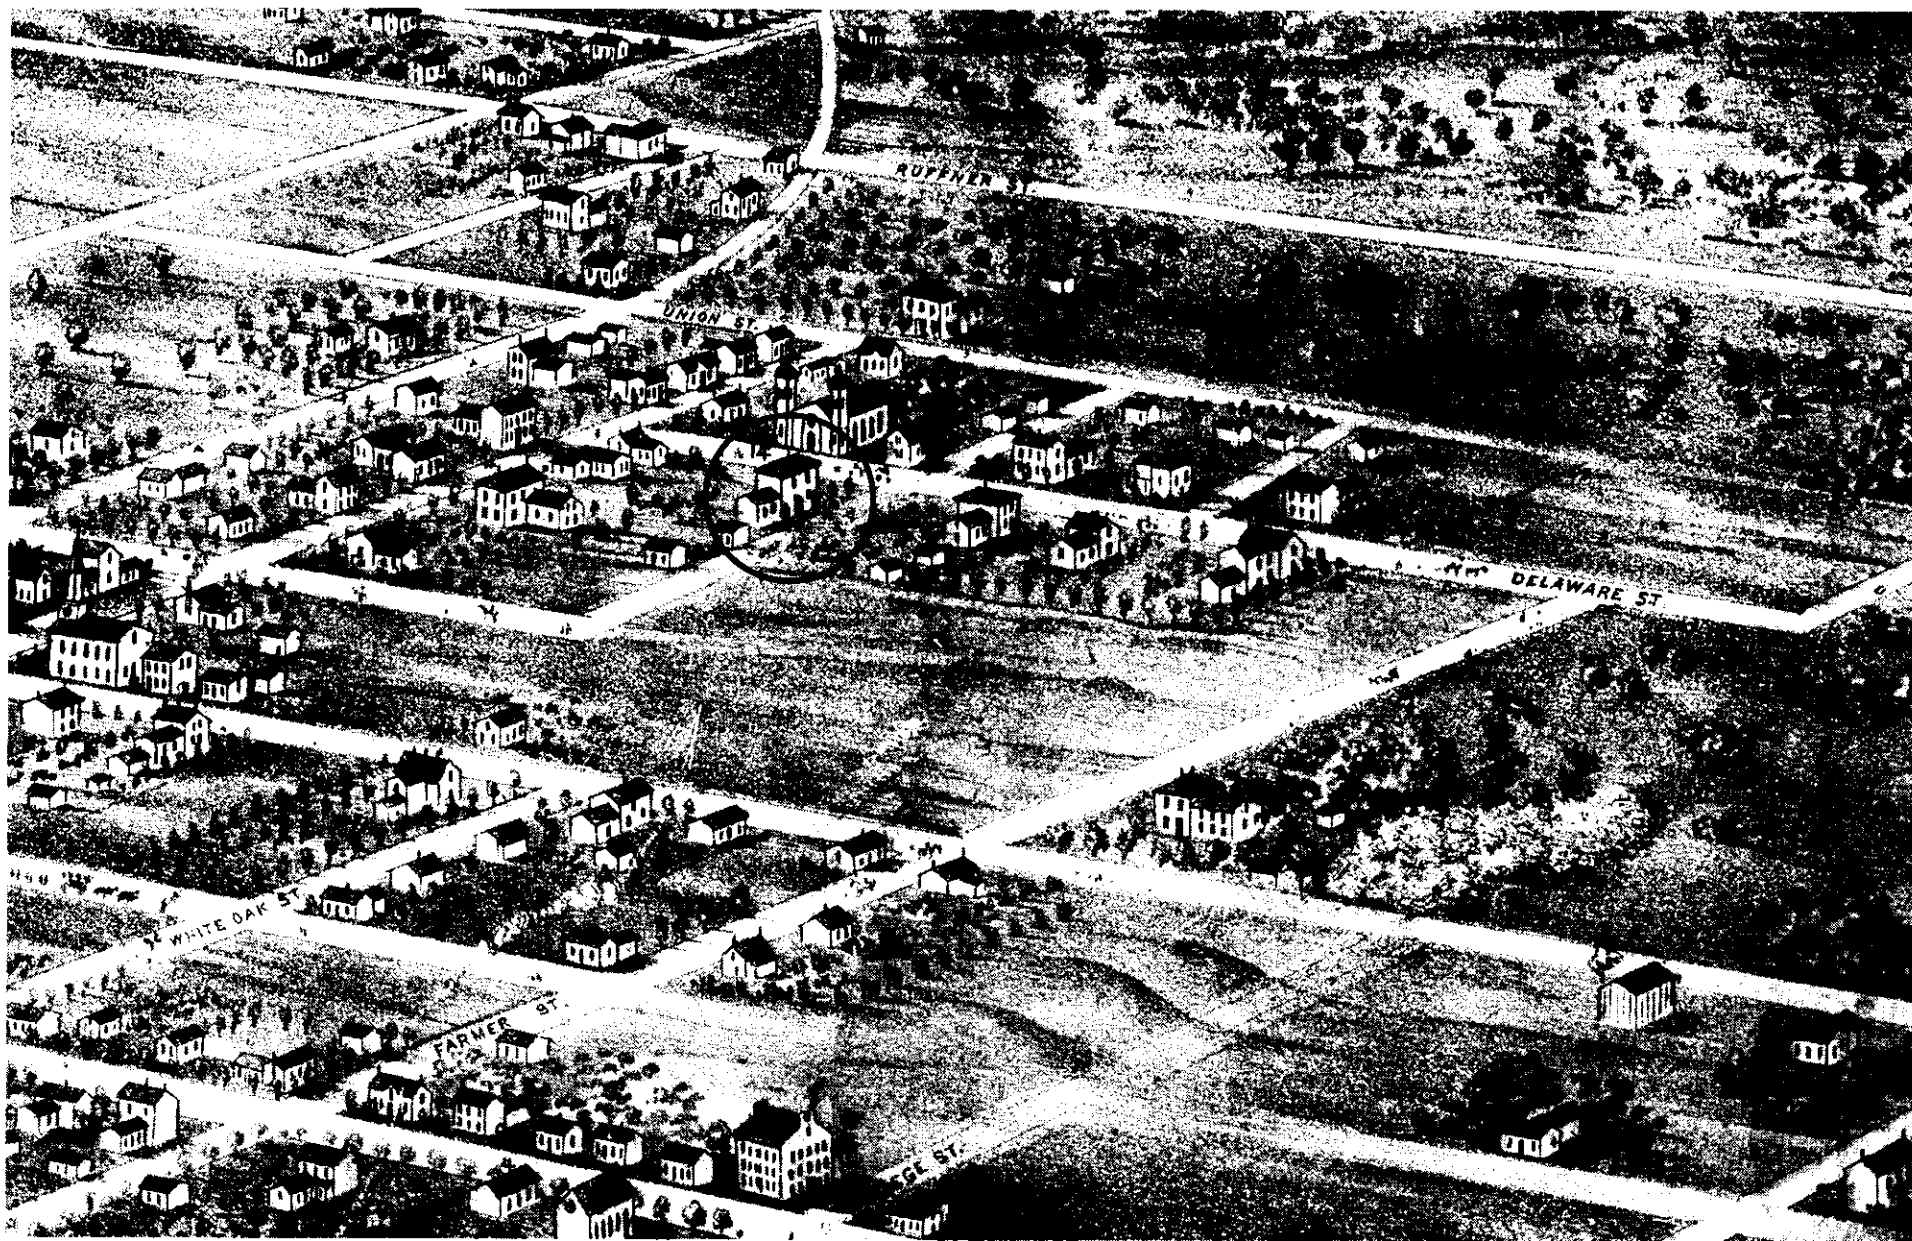
settler from Illinois, paid \$700.00 for both lots (2 and 3), on June 20, 1867.<sup>10</sup> To accommodate his family, there is evidence that in the same year, Gates built a two-story, rectangular structure with a small rear addition.<sup>11</sup> (See Fig. 1.1 and Building Chronology Drawings.)

Fig. 1.1 Bird's Eye View of Independence. A. Ruger, 1868. Detail. Credit: Jackson County Historical Society

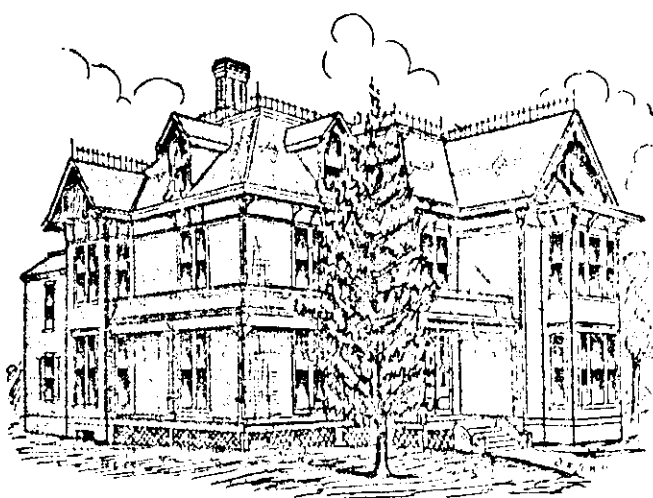
RESIDENCE OF GEO. P. GATES.

As a prominent and successful Independence businessman who had made his fortune from "Queen of the Pantry Flour," George P. Gates decided to construct a sizable "addition" to his home at 219 North Delaware. (See Fig. 1.3 and Appendix E (f), 1886 map.) Designed by builder and architect James W. Adams for \$8,000.00, the house was the most expensive residence built in Independence in 1885.<sup>12</sup> (See Fig. 1.4.) Adams'

Fig. 1.3 Residence of George P. Gates. Independence Sentinel, Independence, Missouri, January 2, 1886. Credit: Harry S Truman Library (HSTL)

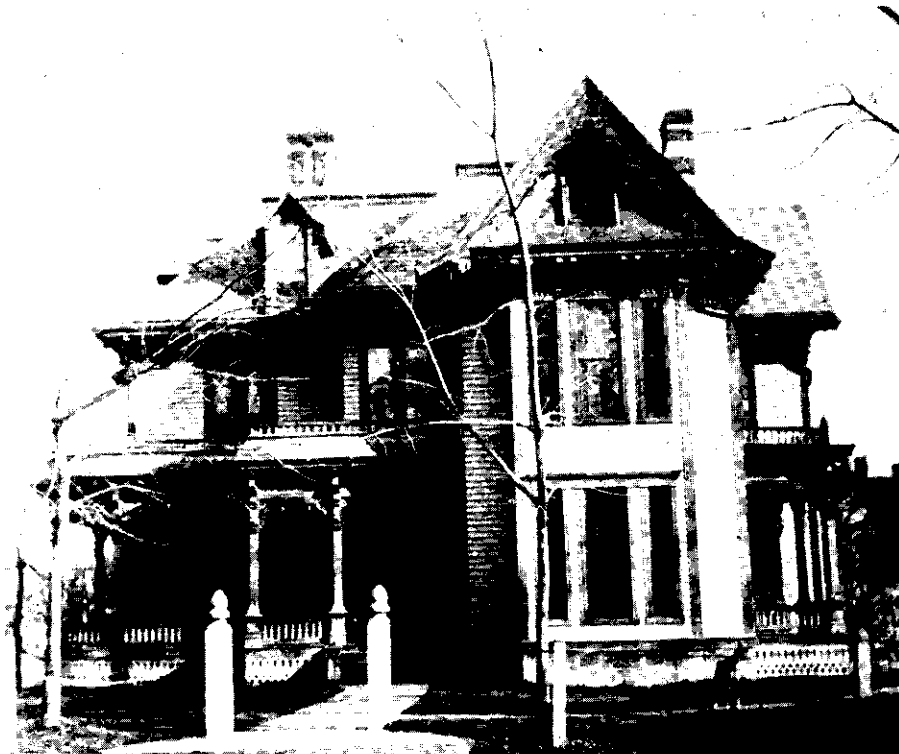
Fig. 1.4 Truman Home, c. 1900. West elevation (looking east). One of a series of the earliest extant photographs of the structure. Note the absence of the roof line decorative grillwork as shown in the 1886 Independence Sentinel. Credit: HSTL

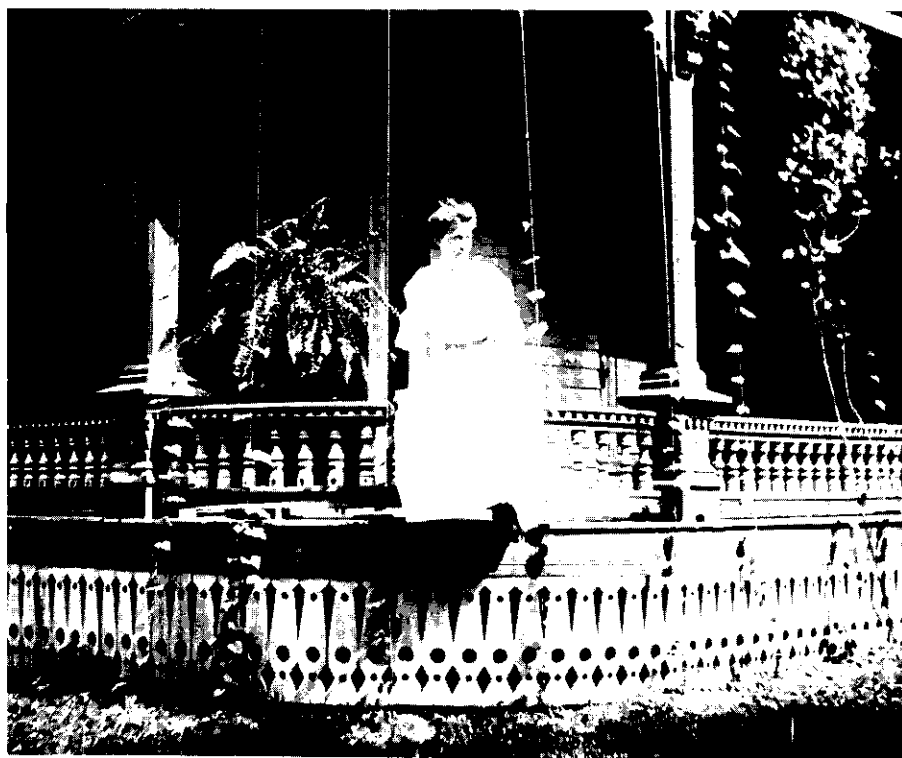
Porches included at the first floor elevation: 104B, 114A, B and C, 101A, and a porch which is now occupied by bathroom 106 and porch 107A. (See Fig. 1.5.)

Fig. 1.5 Truman Home, c. 1905. Porch, northwest elevation (looking southeast). Bess Wallace Truman sitting on the original porch balustrade. Credit: HSTL

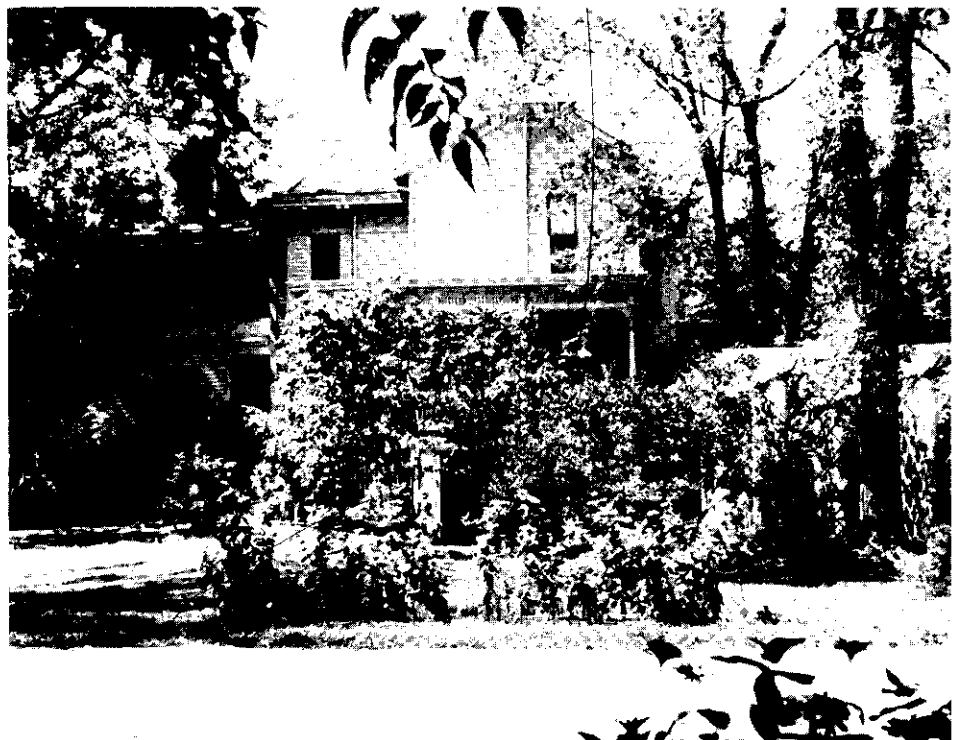
In 1924, after the birth of President and Mrs. Truman's daughter, Mary Margaret, a passageway (206A) was built connecting the Truman's bedroom (205) with the bedroom (210) of their new child.<sup>18</sup> A portion of the second floor sleeping porch was used for the passageway. Also constructed during the 1920s was a backyard pergola (HS-04).<sup>19</sup> (See Fig. 1.7.)

Fig. 1.7 Truman Home, c. 1940. East elevation (looking west). The 1920s pergola is pictured to the right of the rear porch. Credit: HSTL
